# A795 Ambridge Bypass Safety Scheme Stage 2 Road Safety Audit

Date: 21 June 2021

Document Title	A795 Ambridge Bypass Safety Scheme Stage 2 Road Safety Audit	
Author	Michael Juan	
Reference Number	AMB-RSA-S2/06/21	
Owner	Highways England - South West Region - Road Safety Team	
Revision	1.0	
Document Status	Final	
Control Date	21 June 2021

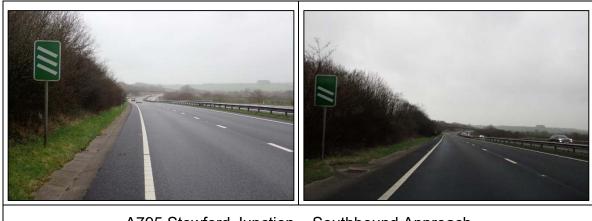
Location A: A795 Stowford Junction – Southbound Approach

Summary: Insufficiently specified vegetation clearance, increasing the risk of injury with loss of control type collisions.

The location of the southbound off slip is located on a gradual left-hand bend and is obscured by the current vegetation after the Advance Directional Sign. This vegetation, which is not in leaf, is also partially obscuring the countdown markers on the approach for this junction and could also obscure the visibility of the proposed Direction Sign. The vegetation clearance shown in the supplied drawing gives no dimension other than area. This may lead to insufficient vegetation being removed and compromise the forward visibility of the road layout being achieved and road users being unable to appreciate the approaching off slip. This could result in loss of control type collisions, risking injury to vehicle occupants.

It is recommended that extents of vegetation are sufficiently detailed so that the intended vegetation clearance is achieved along the southbound approach, making an allowance for seasonal growth.

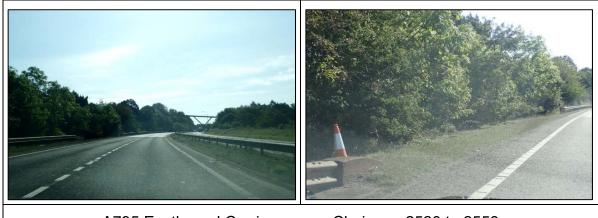
A795 Eastbound Carriageway – Chainage 2520 to 2558

Location B: A795 Southbound Carriageway – Chainage 2520 to 2558

Summary: Existing vegetation within working width of proposed Vehicle Restraint System (VRS), increasing risk of injury if errant vehicle left carriageway.

It is proposed to close the gap in the existing VRS along the southbound carriageway towards the Stowford Junction. At present there is vegetation/trees in this location and appears to be within the working width of the proposed VRS, with no indication that this vegetation is to be removed. Any vegetation/trees that is within the working width of the proposed VRS could impede the operation if struck by an errant vehicle, increasing the risk and severity of injury to vehicle occupants.

It is recommended that all vegetation/trees within the working width of the proposed VRS are removed, with an allowance for seasonal growth.

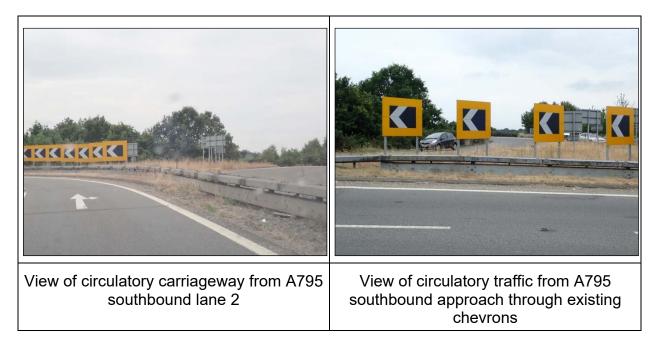
Location C: Splitter island on A795 southbound approach to roundabout

Summary: Screen length enables early roundabout entry decisions and could result in vehicle conflicts.

The proposed exact location of the sight screen is not specified in the supplied drawings but appears to approximately coincide with the existing chevron signs. Partial visibility currently exists between A795 southbound traffic and traffic on the circulatory carriageway to the right of the existing chevrons. On site, some road users were observed to make an early decision to enter the roundabout, accelerating as they approached the existing chevrons, whilst other road users slowed prior to the give way line. However, some visibility of circulatory traffic is possible between the existing chevrons, allowing late braking. Similar visibility of the circulatory carriageway is expected to the right of the proposed sight screen, but the proposed sight screen will remove visibility to the right from adjacent vehicles. This may lead to shunt-type collisions between accelerating and braking vehicles on the southbound approach and vehicle conflicts at the southbound roundabout entry. This risks injury to vehicle occupants.

It is recommended that the sight screen is extended as far north as practicable to minimise visibility between A795 southbound traffic and traffic on the circulatory carriageway.

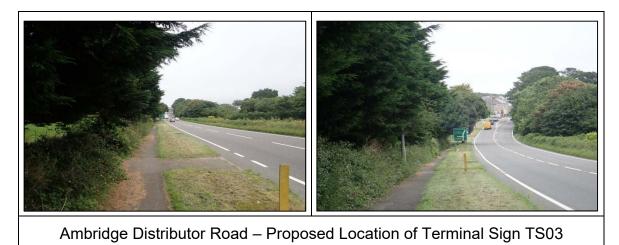
- Location D: Ambridge Distributor Road Eastbound & Westbound Approach 30mph Terminal Sign TS03 & TS16
- Summary: Mounting height of sign adjacent to footpath may be struck by cyclists.

The location of the combined traffic sign TS03 & TS08 is in the grass verge, on the eastbound approach and adjacent to a footpath and is shown to have a mounting height of 1800mm. The location of the combined traffic sign TS16 & TS17 is in the grass verge, on the westbound approach and adjacent to a footpath and the existing sign is known to have a mounting height of 1900mm Although this footpath is not designated for shared use (cyclists & pedestrians), it is known and been observed on previous site visits in this area that cyclists do regularly utilise this footpath when travelling to and from Ambridge along the Ambridge Distributor Road. The lower part of the sign could be struck by cyclists when travelling past this sign, increasing the risk of injury. This could be more of a concern with the removal of street lighting on the approach to the sign in combination with cycling along this section during the darker mornings & evenings.

It is recommended that the mounting height of this sign combination is at an appropriate height for all vulnerable road users.

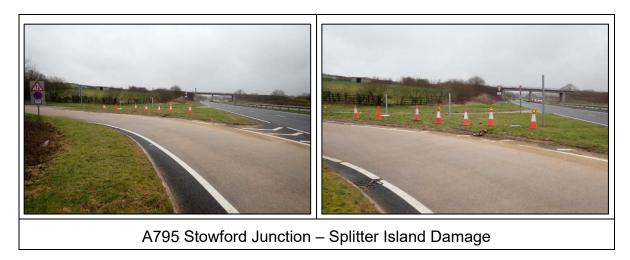
Location E: A795 Stowford Junction – Splitter Island

Summary: Removal of Direction Sign from Splitter Island may lead to late braking and loss of control collisions.

It is proposed to relocate the Direction Sign from its current location on the splitter island to the commencement of the off slip for the junction within the nearside verge. The proposed marker posts for the splitter island may not clearly identify the junction for approaching motorists. During the site visit it was clear that motorists have been involved in loss of control type collisions and have demolished the direction sign and all the chevron signs on the splitter island.

It is recommended that the splitter island for approaching motorist is clearly identifiable, for example by replacing the existing chevrons signs on the splitter island with a more durable set and extending further along the island towards the nosing.

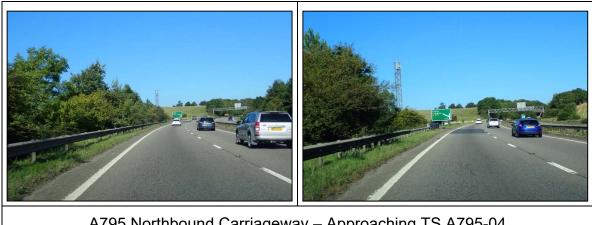
A795 Northbound Carriageway – Approaching TS A795-04

#### Location F: A795 Northbound Carriageway – TS A795-04

Summary: Proposed location of Advance Direction Sign (ADS) may not be protected by existing VRS, increasing risk of injury if errant vehicle left carriageway.

It is proposed to replace the existing ADS (TS A795-04) to a new location 5m in a northerly direction. The ADS is protected by the current VRS with an existing 8 metres of full height barrier after the sign assembly. The proposed location of the new ADS will place the new sign 5m north and in doing so, will only leave approximately 3m of full height barrier after this proposed assembly. The new location of the ADS in conjunction with the existing VRS may result in the VRS not performing as designed and increase the severity of injury to vehicle occupants if an errant vehicle left the carriageway at this location.

It is recommended that the proposed new sign assembly is adequately protected by the existing VRS.
