SoRSA - East Midlands Road Safety Workshop 2024

Is this a crash problem?

B1257 & The Balk crossroads, Slingsby, North Yorkshire

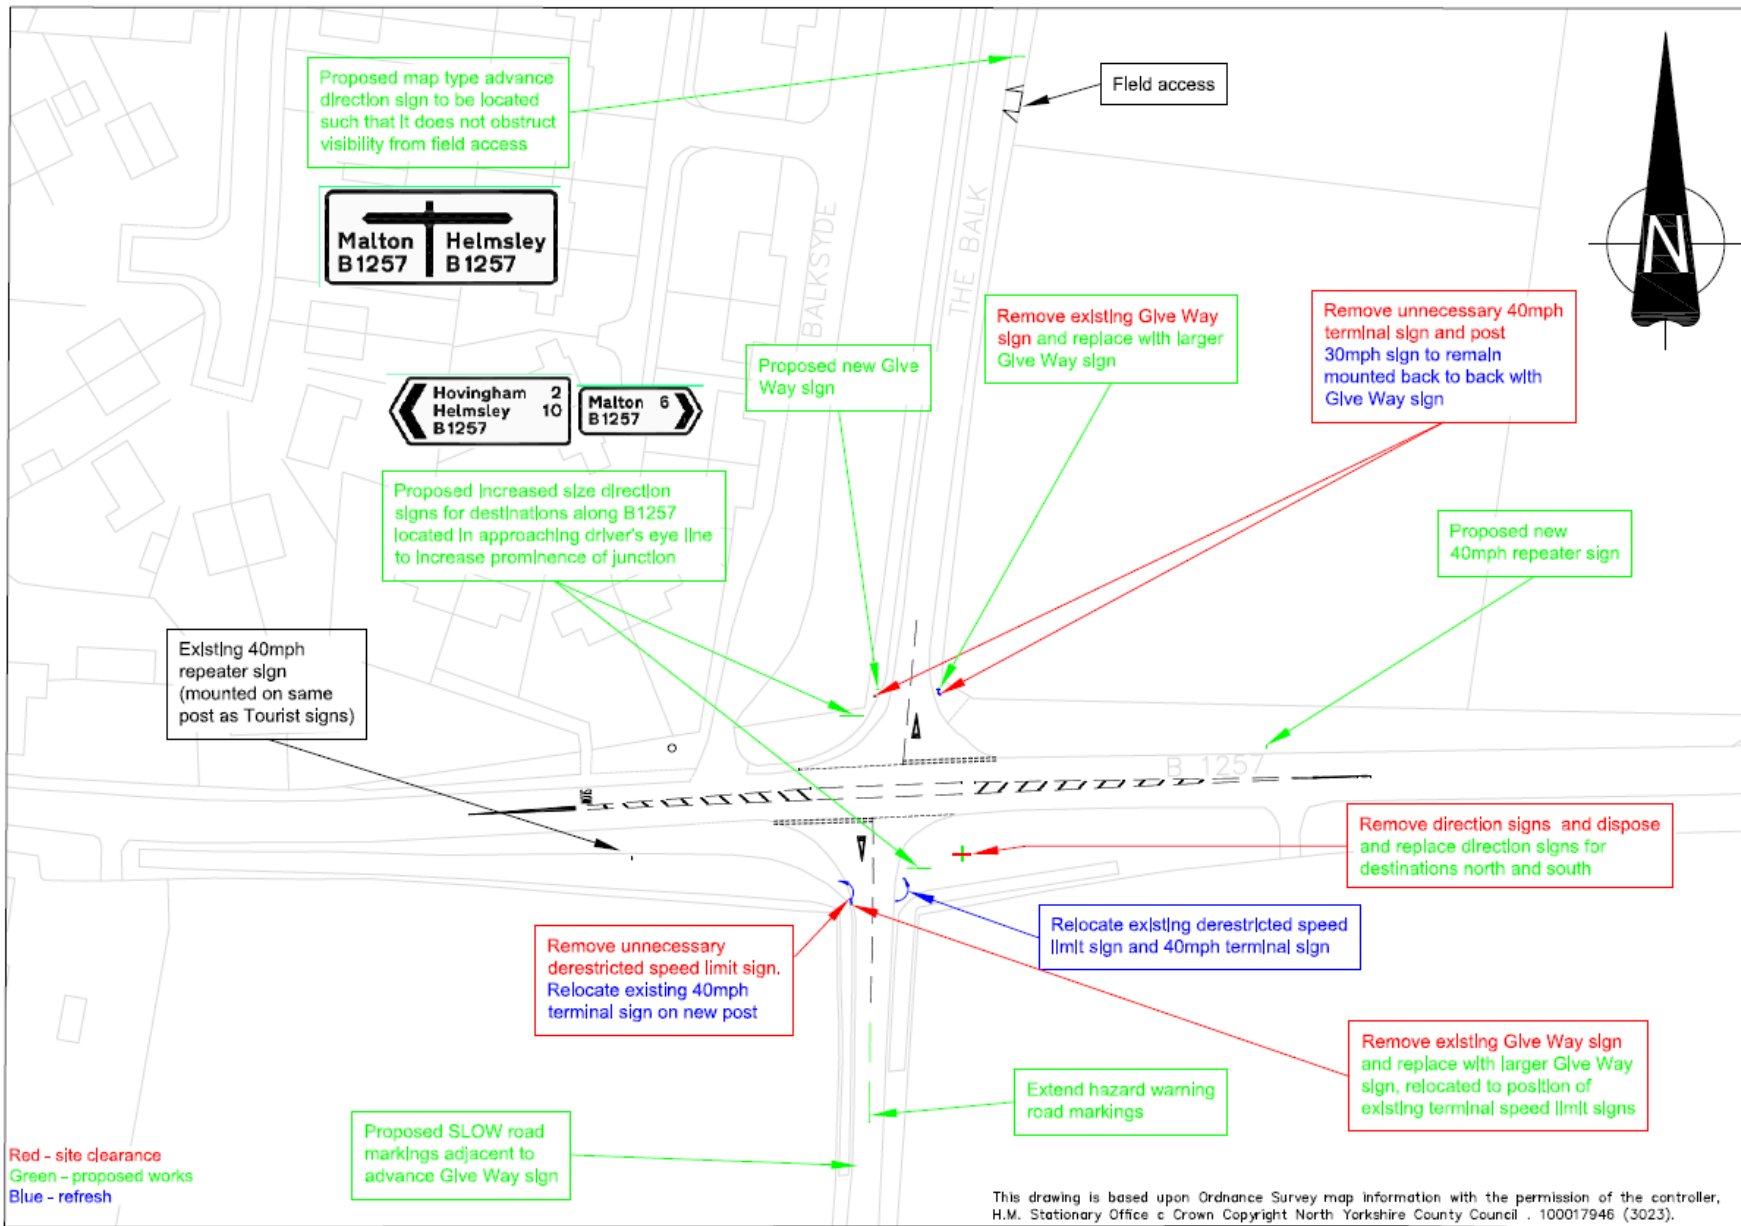
<p>© Crown Copyright and Database Rights Ordnance Survey Licence No. 100017546 2023</p> <p>The Baulk, Slingsby Aug 2015 - July 2021 Accidents between dates 01/08/2015 and 13/07/2021 Selected using Pre-defined Query :</p>	SCALE	1 : 3170
		DATE	03/11/2023
		DRAWING No.	
		DRAWN BY

- Cost of scheme ≈ £4,000
- No collisions recorded at junction in the five years following installation
- 08/09/2017 V1 and V2 travelling east on B1257. V1 alleges to be dazzled by the sun and runs into the rear of V2.
- 28/08/2018 V1 travelling west to east on B1257. V2 travelling east to west and turns into junction of High Street and U turns to face west. V2 exits junction in eastbound direction, V1 collides with side of V2 as it moves out onto Malton Road
- 06/09/2018 Motorcycle making left turn onto High Street loses control due to mud on the road following heavy rain.

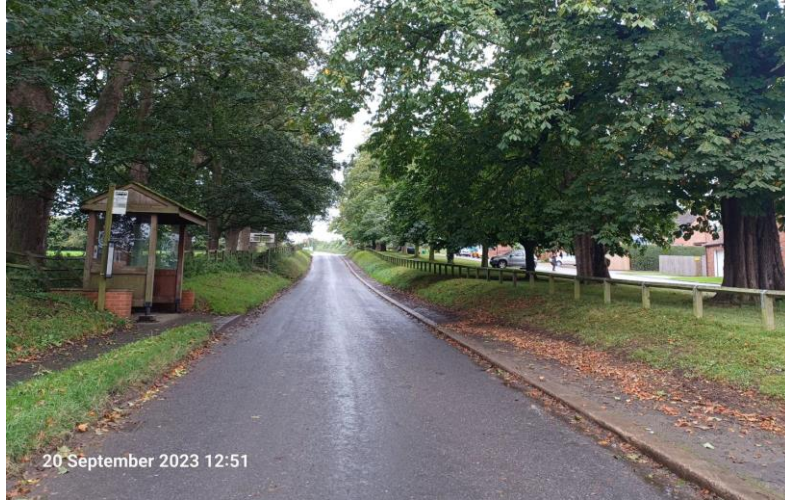
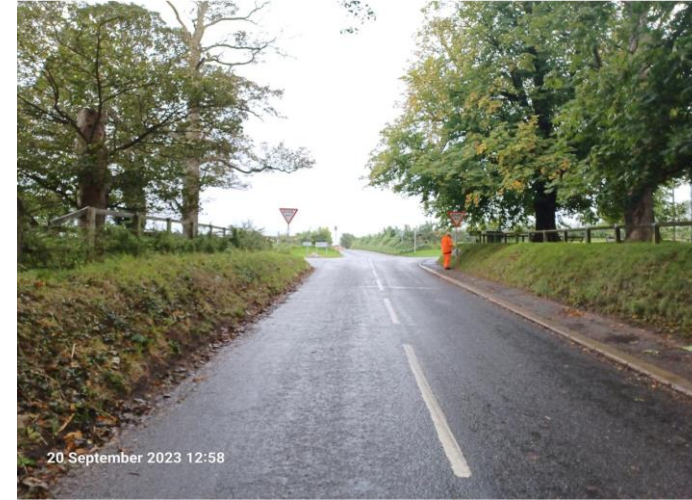
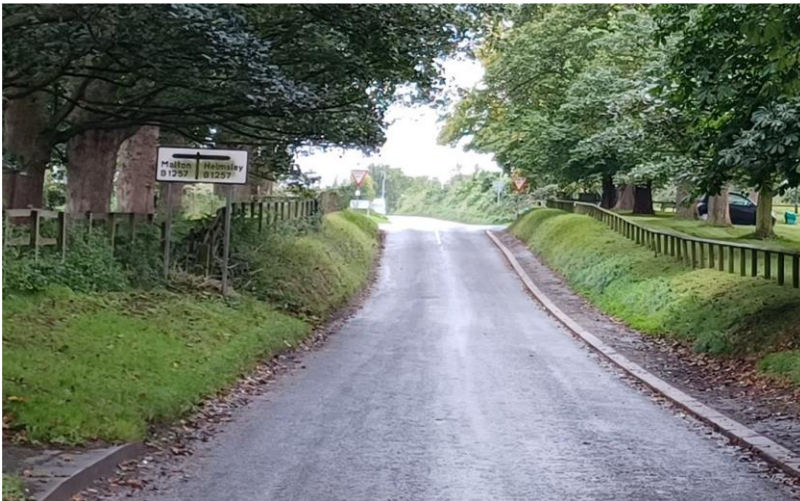
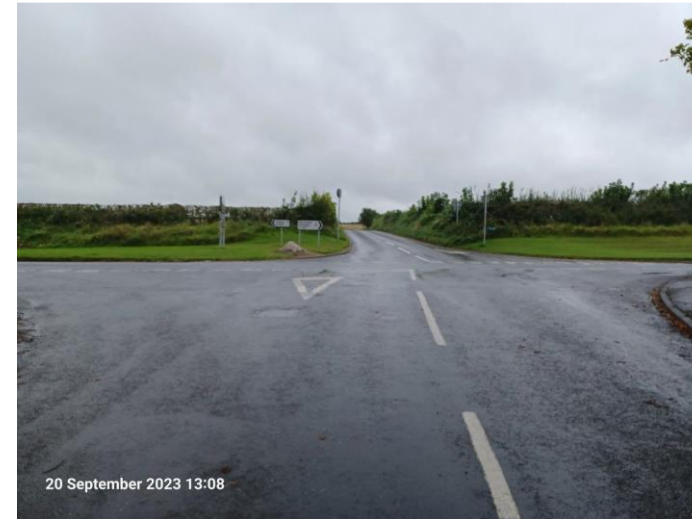
Public liability claim; poor road signs and warning there is a crossroads

Insurance and Risk Management Team suggest it is prudent to consider if the local authority is potentially at risk here on the basis of the type and placing of signage/markings. Is it possible to provide a formal report relating to signage etc.?

There is no specific requirement within the legislation, regulations, design standards or guidance listed below to provide signs or road markings at a junction with a minor road with a 30mph speed limit and a B class road with a 40mph speed limit.
